**KOTMALE POWER STATION**  
**CEYLON ELECTRICITY BOARD**

**REPORT ON UNIT 02 STATOR WINDING REPAIR**

Prepared By:	Checked By:	August 2011
Nizam Salih Electrical Engineer (Maintenance) Kotmale Power Station	T.M.S.K Tillekaratne Chief Engineer Kotmale Power Station	Date of fault occurred: June 19, 2011

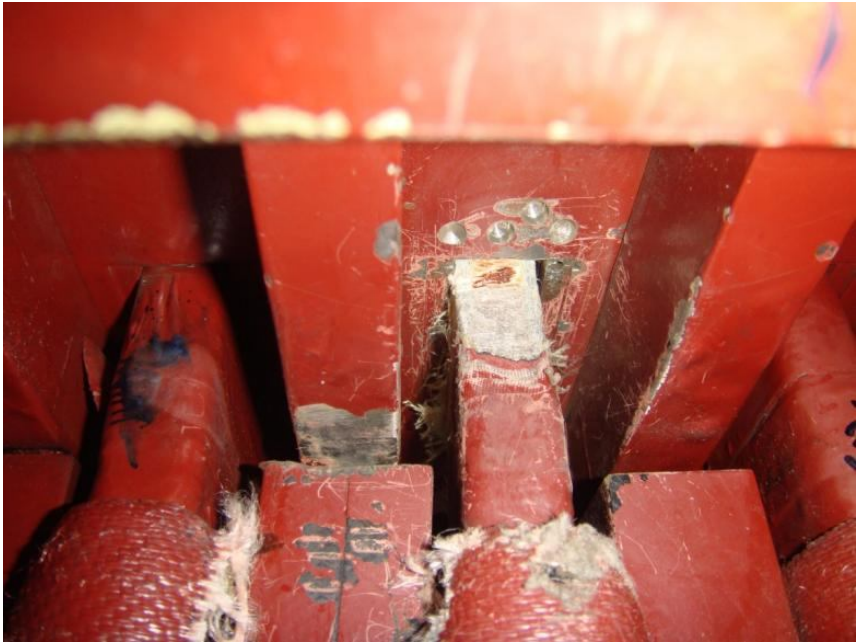
A high voltage test was conducted by Colombo City cable testing unit. Flashes inside the stator could be heard and observed when the applied voltage was 4kV dc. On further inspection and testing it was confirmed that the arching was taking place at the bottom of conductor 130 (slot 130) of the stator.

It was suspected that the arching at slot 130 to be between conductor insulation and the walls of the slot at the stator bottom not far from the slot wall end where free coil parts coming out of the iron core.

Therefore the insulation between the conductor and walls of the slot was partly removed to get space to insert new insulation material. This was a very tedious job and took almost two continuous days to remove the insulation up to about 3cm depth.

After the continued removing of the insulation around the slot 130 conductor for about 3cm the earth fault disappeared. This happened on 25<sup>th</sup> June, 2011 after 06 days of the failure.

Table 3.1 shows the Insulation Resistance readings taken after clearing the fault. No insulation was applied at this time of taking readings. Fig. 3.1 shows the area of slot 130 where the work was carried out.

Fig. 3.1 Slot 130 where insulation was removed between conductor and Slot walls for a depth of about 3cm.

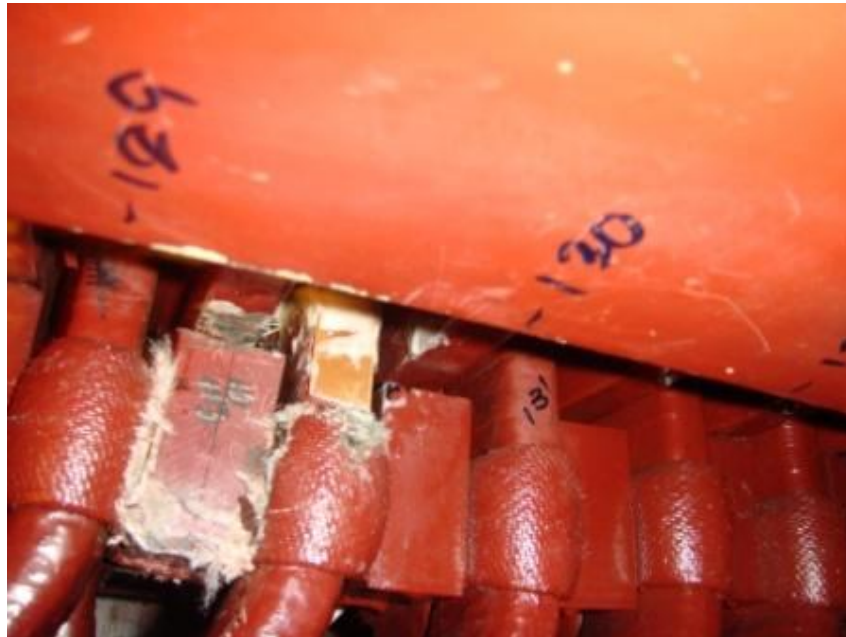
The earth fault at this time was suspected to be a loosen stator iron core lamination damaging the conductor insulation and thus making the conductor to be earthed. As a temporary measure AMHE staff used a resin and hardener mixed to glass powder to insulate between conductor and the slot walls where the insulation was removed. This was done on 26.06.2011.

Fig. 3.2 shows the status of the slot 130 bottom area after applying the insulation. Here two numbers T=0.5 slot fillings were used with the above insulation as can be seen in fig. 3.2

Fig. 3.2 The status of the slot after applying the insulation and slot filling

The insulation applied to the conductor in slot 130 was a temporary measure. Stator windings were not tested for voltages higher than 1 KV. It has been 25 years since the generator is in service. A complete rehabilitation of the U2 generator is recommended.
